July 27 2010

**WATER EROSION, CYLINDER BLOCKS**

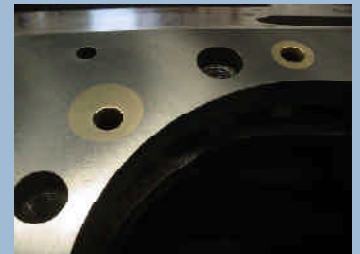
Commonly found around coolant passages, severe erosion leads to coolant leaks. This can be prevented without sacrificing the integrity or life of the block.

With one of the most advanced block departments in the world, B&G offers a solution that extends the life of the block. Using our programmable 3-axis CNC block machines, we can identify each of these water passages in their exact location. Each passage is then machined to allow proper press fit. Non-corrosive inserts are installed and machined using 3-axis programming. Finally, the entire block deck is surfaced for proper gasket sealing characteristics.

**INSTALLING NON-CORROSIVE DECK INSERTS OFFERS**

- ◆ **Eliminates future water passage erosion on the deck**
- ◆ **Proper gasket and ferrule sealing**
- ◆ **Long-term reliability**
